**Flood Control Project Maintenance
Levee Inspections**

Fall 2010 Levee Maintenance Deficiency Summary Report

San Joaquin River Basin

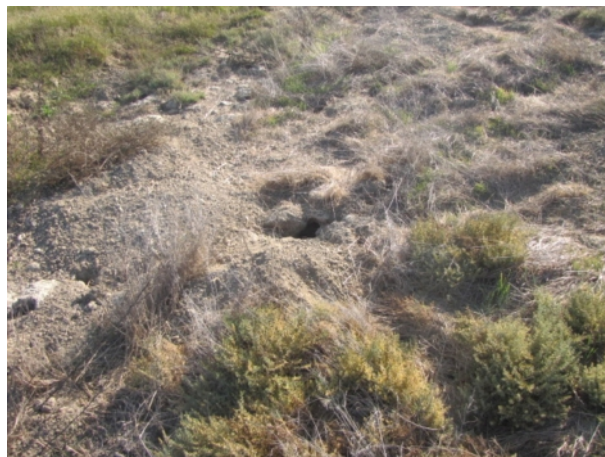
richard_f_20101122_400.jpg

Typical view of squirrel burrows in this section of levee

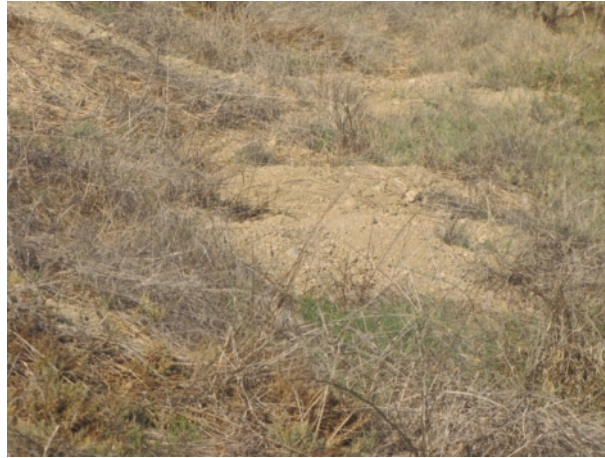
richard_f_20101122_403.jpg

Looking at typical view of squirrel burrows on landside slope in this section of levee.

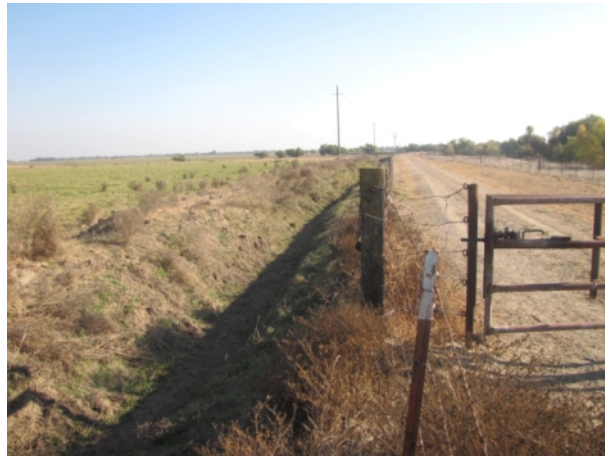
richard_f_20101122_401.jpg

Looking south at irrigation ditch along landside toe.

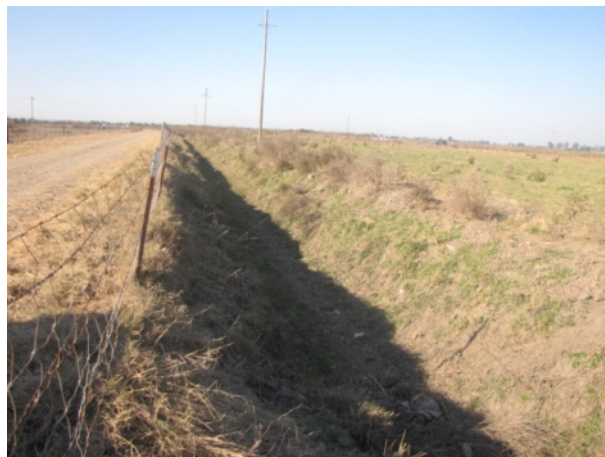
richard_f_20101122_402.jpg

Looking north at irrigation ditch along landside toe.

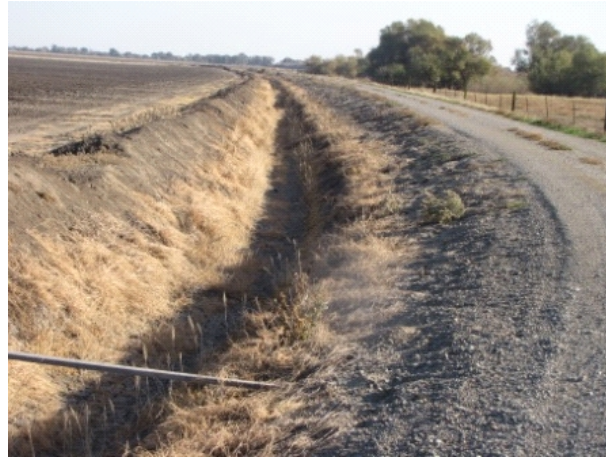
richard_f_20100921_017.jpg

Looking at landside ditch at levee toe.

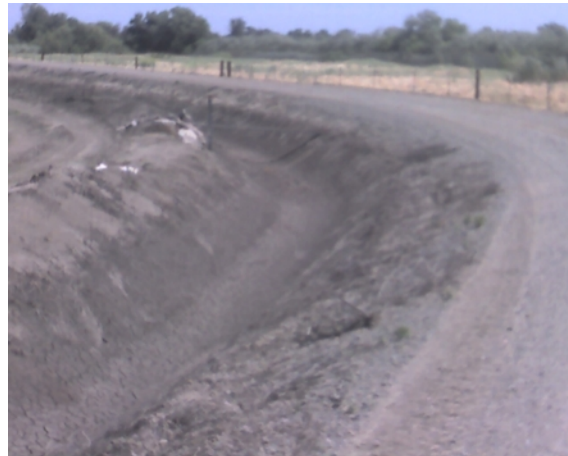
richard_f_20100921_018.jpg

Looking southeast at ditch along landside toe.

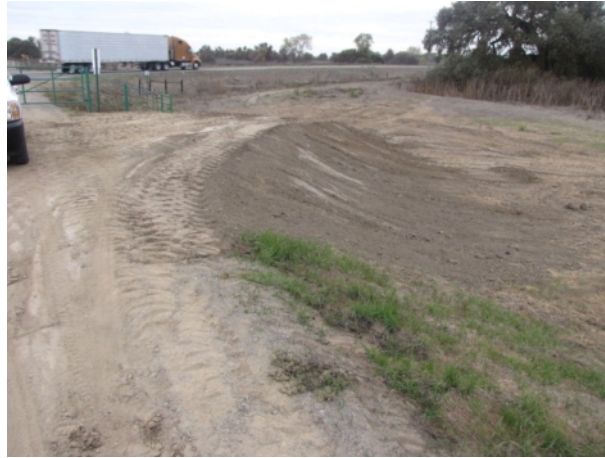
richard_f_20101123_458.jpg

Looking downstream (northeast) at new ramp on waterside slope.

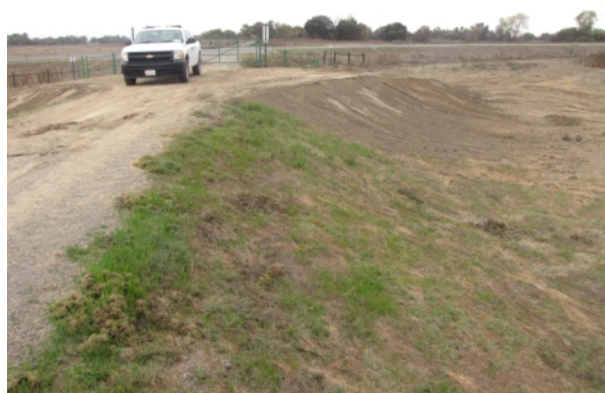
richard_f_20101123_459.jpg

Looking downstream (north) at new ramp on waterside slope.

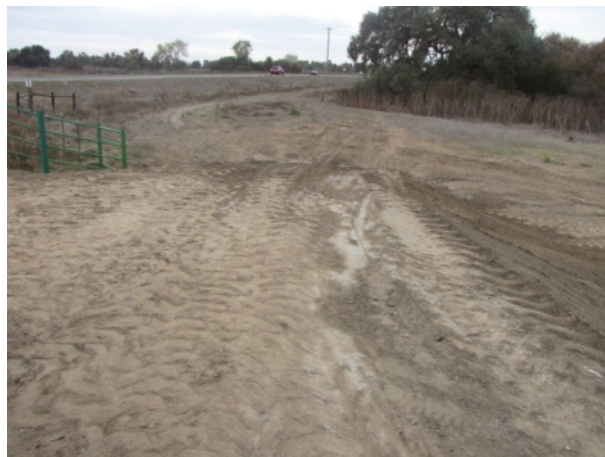
richard_f_20101123_460.jpg

Looking east at new ramp on waterside slope.

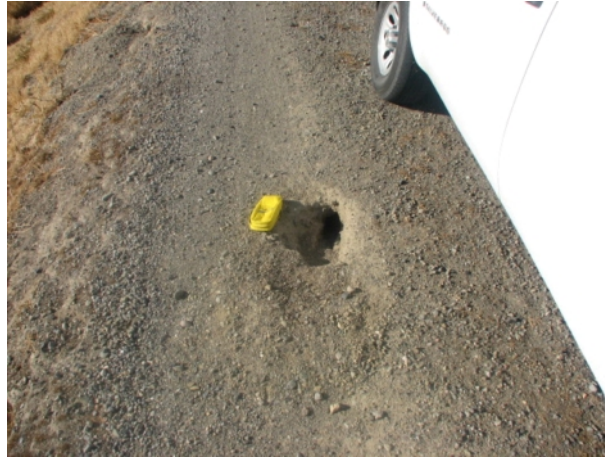
richard_f_20100921_027.jpg

Looking at squirrel hole on crown of levee.

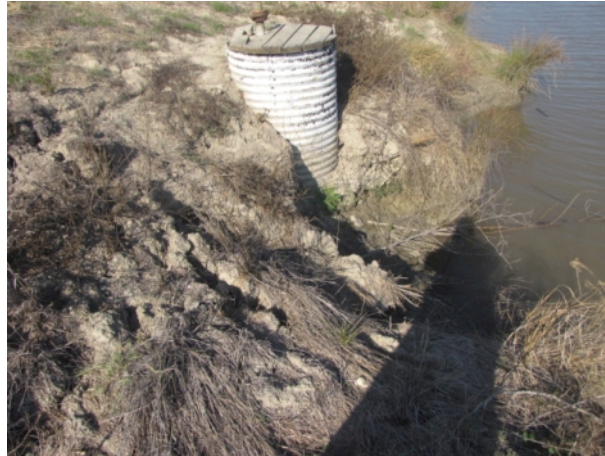
| richard_f_20101122_416.jpg | |

| Looking downstream at erosion around screw gate can on waterside slope. | |

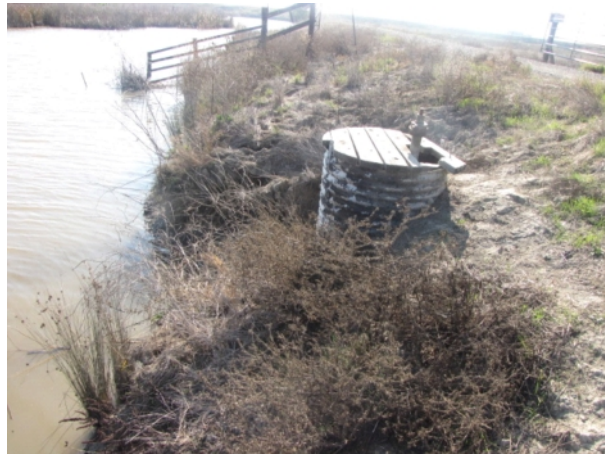
| richard_f_20101122_417.jpg | |

| Looking upstream at erosion around screw gate can. | |

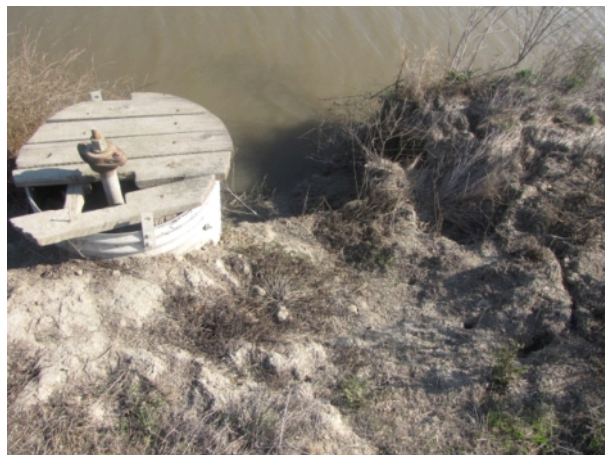
| richard_f_20101122_418.jpg | |

| Looking at erosion near and around screw gate can. | |

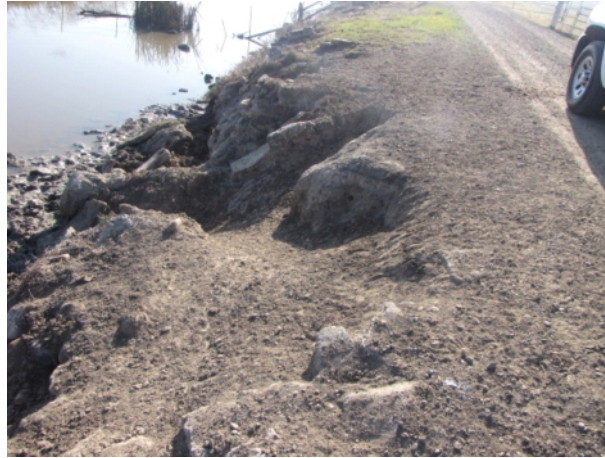
richard_f_20101122_414.jpg

Looking upstream at one of several slope stability along canal.

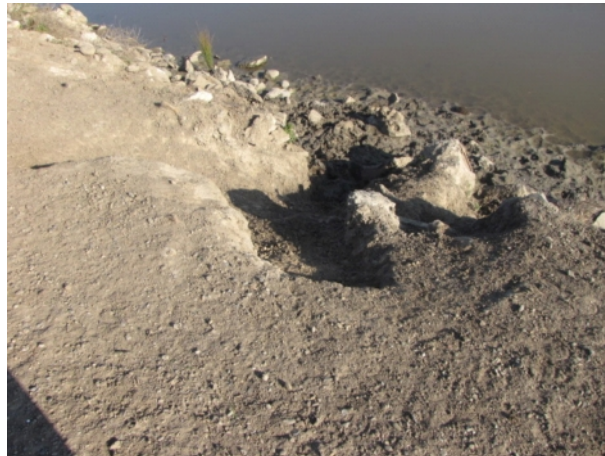
richard_f_20101122_415.jpg

Looking at one of several slope stability along canal.

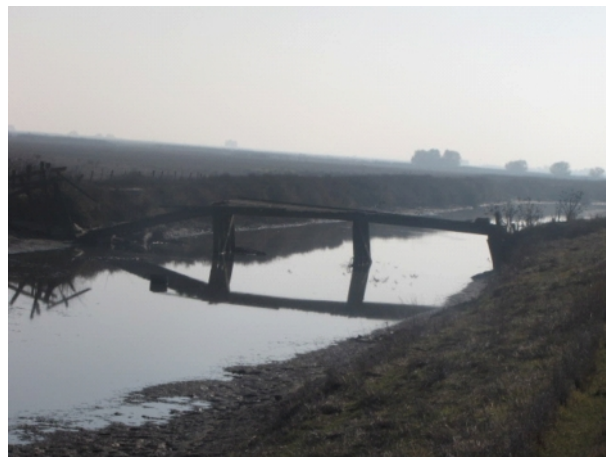
richard_f_20101122_408.jpg

Looking downstream at dilapidated bridge in channel.

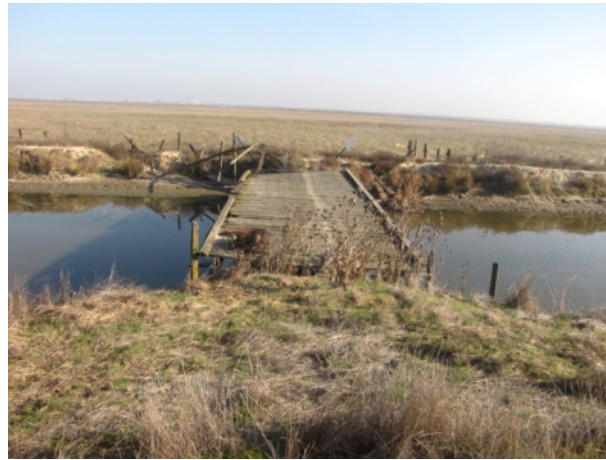
richard_f_20101122_409.jpg

Looking southeast at dilapidated bridge in channel.

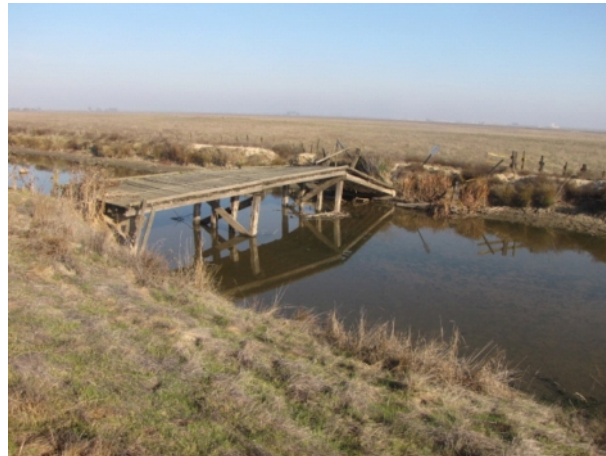
richard_f_20101122_410.jpg

Looking northeast at dilapidated bridge in channel.

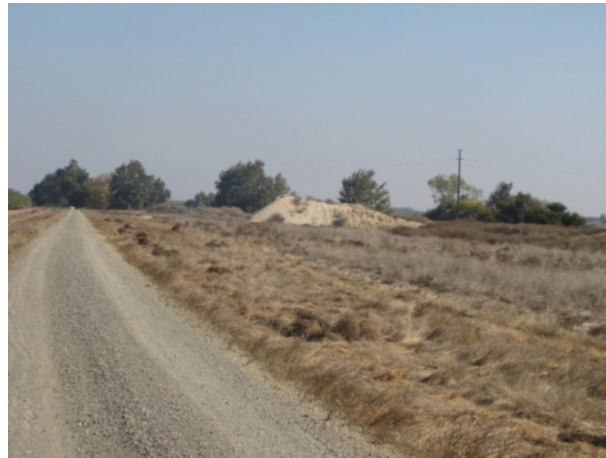
richard_f_20101122_437.jpg

Looking upstream (south) at sand pile within 100' of waterside levee toe.

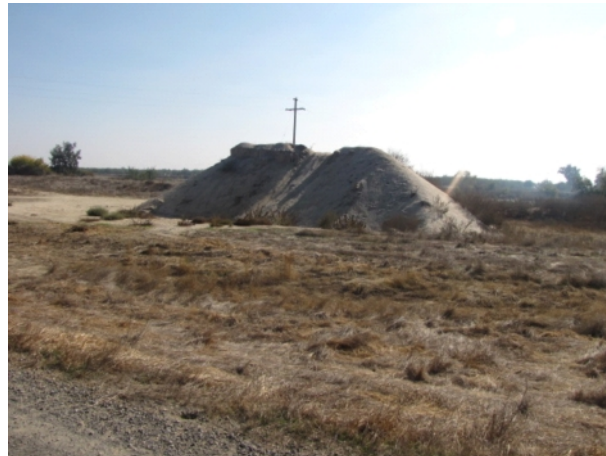
richard_f_20101122_438.jpg

Looking southwest at sand pile within 100' of waterside levee toe.

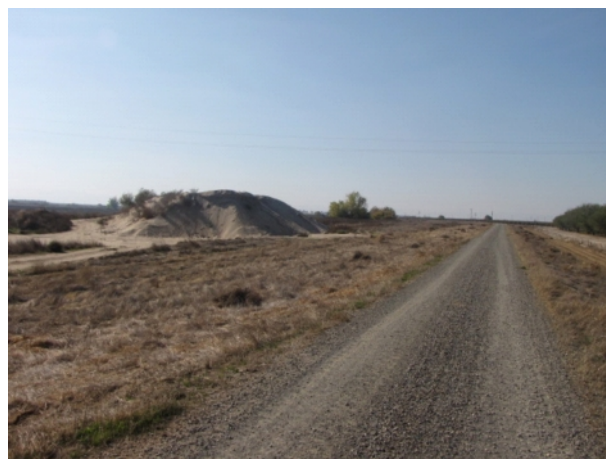
richard_f_20101122_439.jpg

Looking downstream (north) at sandpile within 100' of waterside levee toe.
